HAMTRAMCK STADIUM

Pre-Development Planning

HISTORIC STRUCTURE REPORT

JUNE 2018

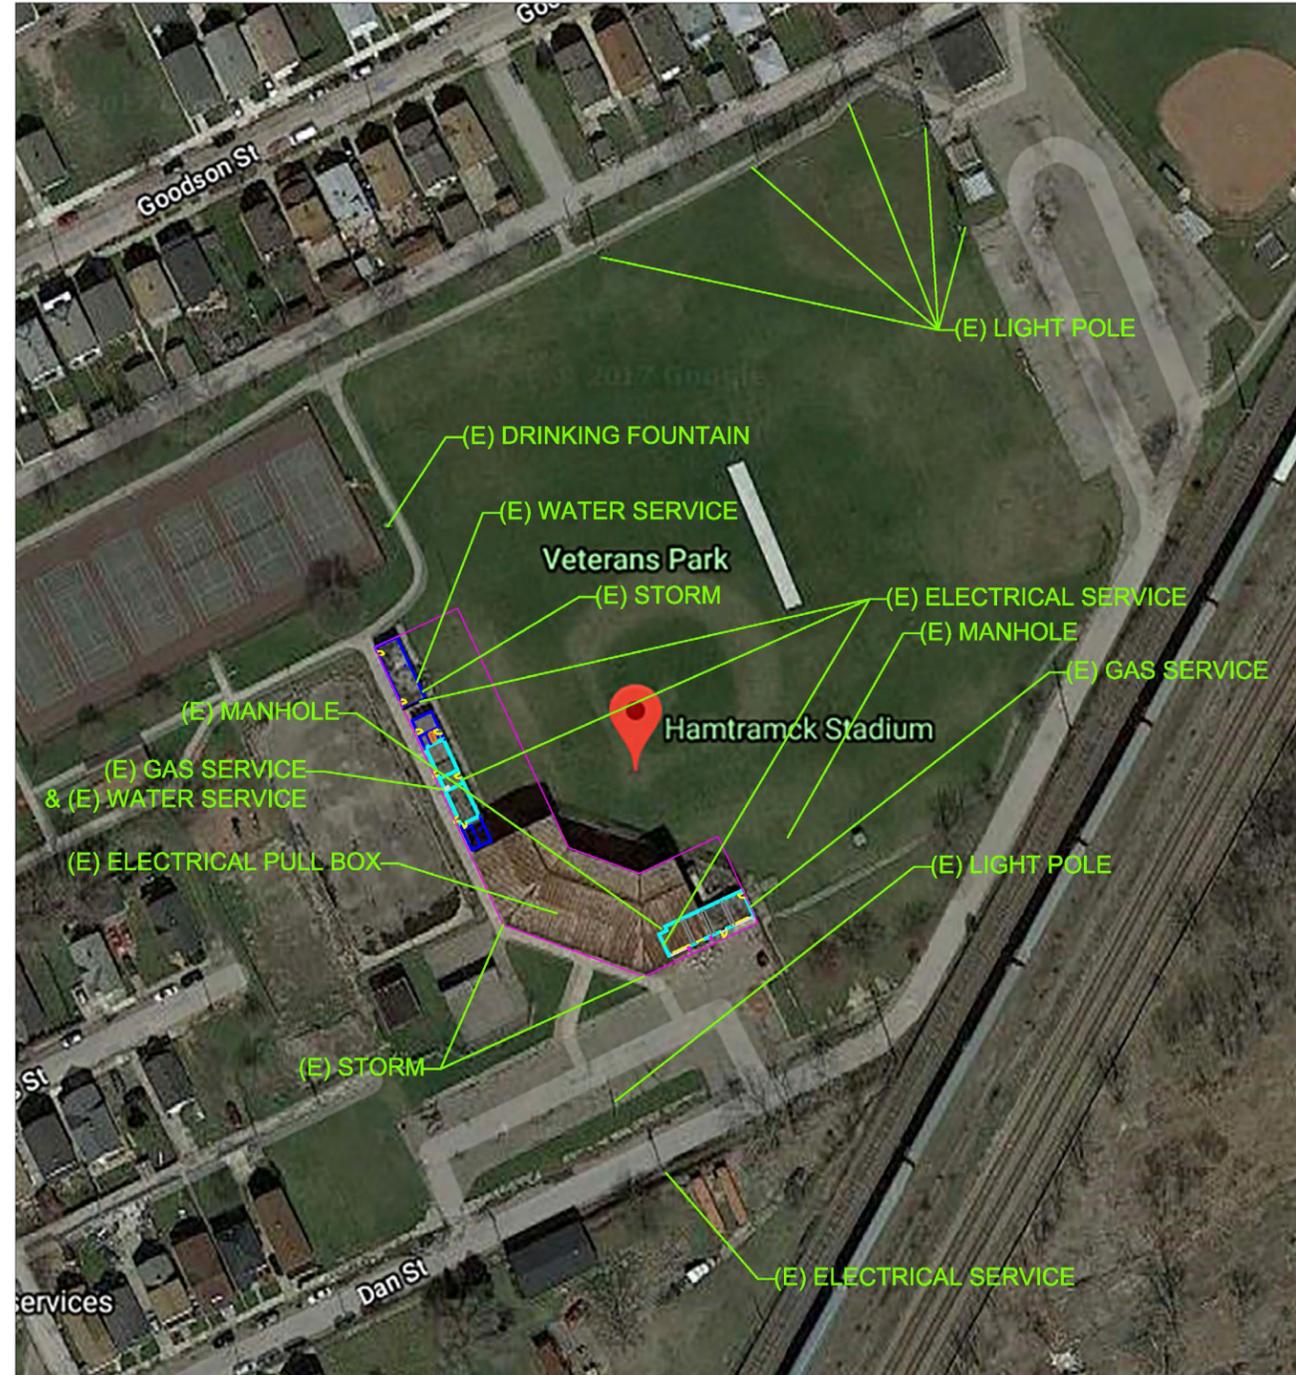
Figure 3.19
Existing Site Utilities

A drinking fountain on the site is assumed to be served from the piping observed in Building 5.

There is currently one light pole in the south portion of the parking lot that is connected to the same electrical pole as the incoming electrical service is provided from. While the light pole is powered, it was not able to be determined if the light pole is active and operational. No meter for the light pole was identified and it is assumed that the service to the light pole is separate from the service identified to Building 2.

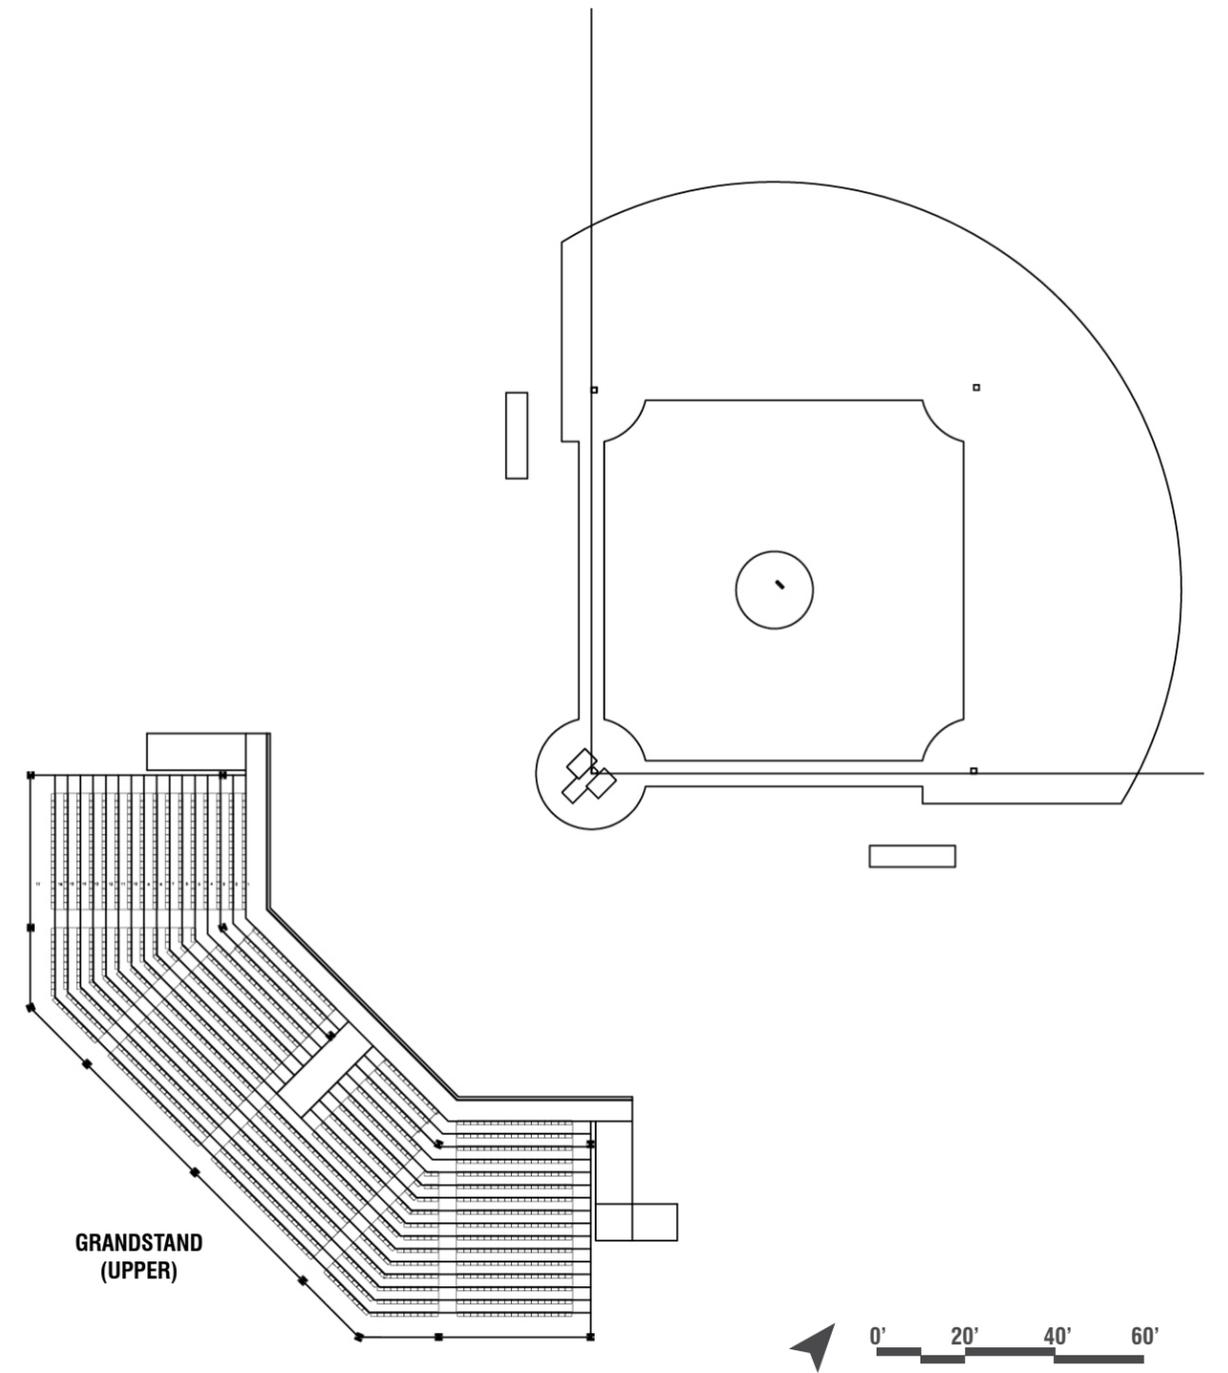
Figure 3.26 Existing Structures
Grandstand Seating

The existing grandstand is a structural steel and timber framed structure. In general the structure appears to be in fair condition. There is some corrosion of the steel framing and deterioration of the wood framing as described further.

A matrix of 54 steel columns supports the grandstand seating area. The columns are spaced approximately 11'-6" apart along the length of the seating area and at varied spacing from approximately 8'-0" to 15'-0" in the opposite direction. 14 of the columns extend above the grandstand seating area to support the grandstand roof. The columns which extend up are 14" deep wideflanges, all other columns are 8" deep wideflanges. The columns appear to be in fair condition with some minor corrosion.

The columns have steel base plates which bear on concrete piers that range in size from 12" x 12" square for the 8" wideflange columns up to 24" x 30" for the larger 14" columns. The columns are anchored to the concrete piers with (2) anchor rods. Many of the column base connections are corroded, a majority of which is minor corrosion. Approximately 25% of the columns base connections have experienced more severe corrosion, including corrosion of the baseplate and other steel attachments, damage to the anchor rods, and section loss to the bottom portion of the steel column.

The steel columns support a framework of wood and steel framing. Along the length of the seating, supporting the lower portion of the grandstands is a series of built-up wood girders consisting of (4) 2x12's bear over top of the steel columns. Supporting the upper levels there is a series of steel wideflange girders that frame into the wideflange columns. Bearing on the wood and steel girders are intermediate built-up wood beams located at a spacing of approximately 5'-0" which consist of (3) 2x12's. The wood and steel framing appear to be in fair condition, only minor corrosion was noted.

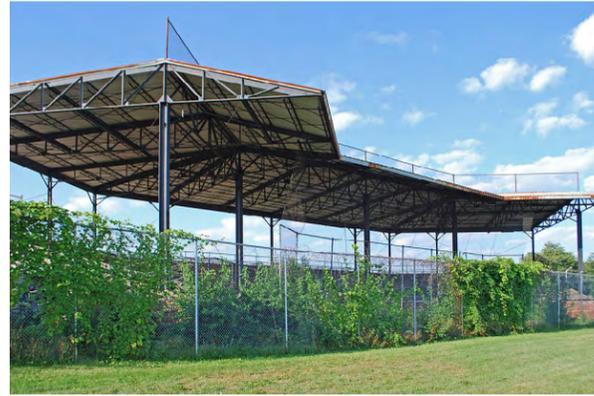
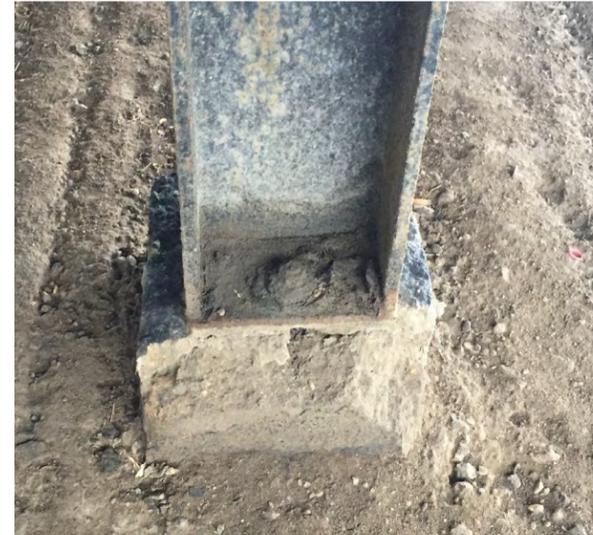
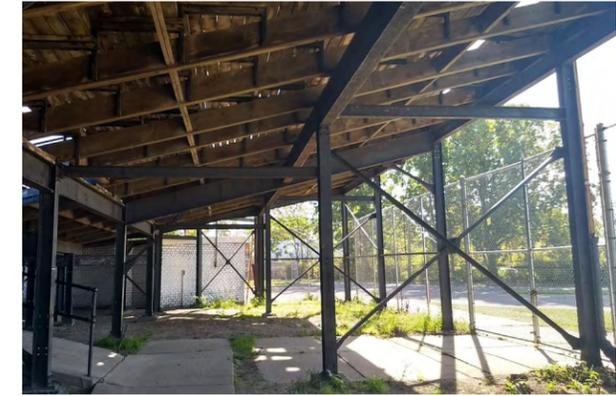
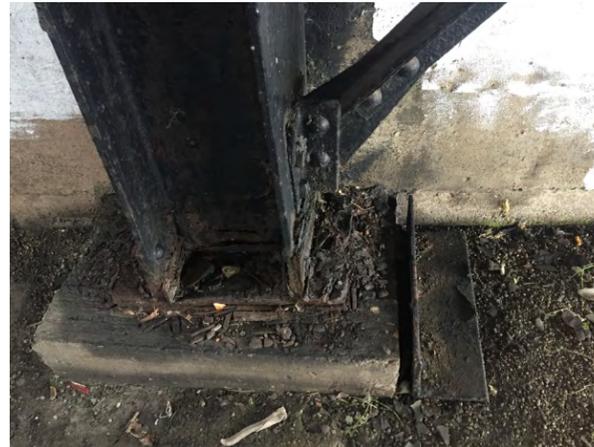
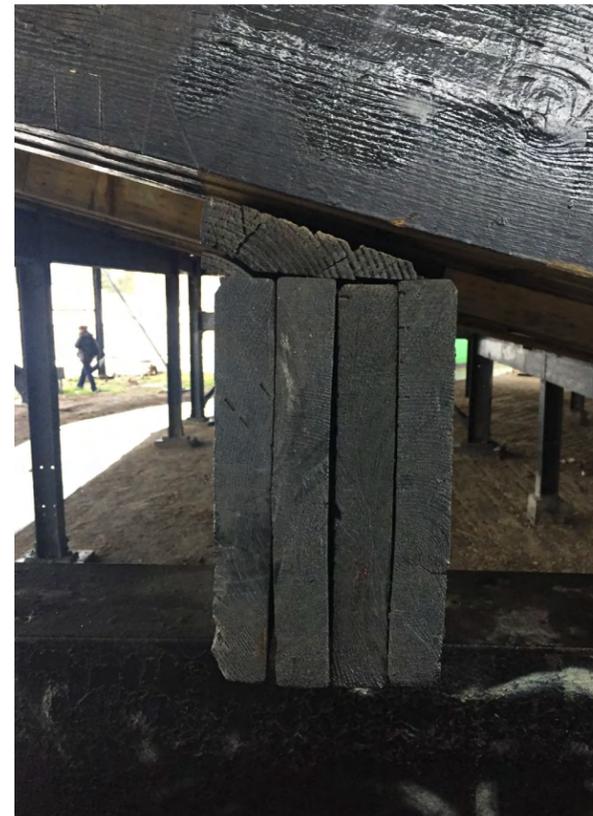
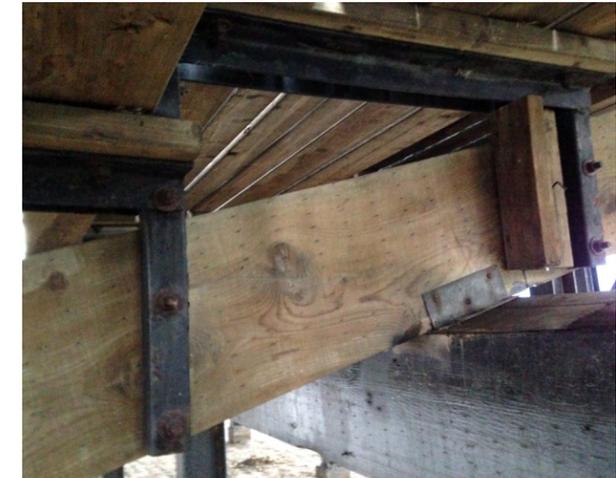
The tiered grandstand walking surface and seating is supported by a series of steel tube supports bolted to the side of the intermediate built-up wood framing. The walking surface is 1x6 wood flooring and seating is 2x wood framing. Portions of the walking surface and seating is missing and much of what remains is severely deteriorated.

Lateral support for the grandstand in the direction perpendicular to the length of the seating is provided by a series of steel cross bracing and knee braces. These braces consist of steel angles. Lateral support for the grandstand in the direction along the length of the seating is provided by steel cross braces

Figure 3.27
Grandstand Structure

Figure 3.35
Deteriorated bleachers

Figure 3.37
Lateral support

Figure 3.38
Grandstand roof structure

The existing grandstand roof consists of steel trusses spanning between columns in the direction perpendicular to the length of the seating, the ends of the trusses cantilever to provide additional coverage over the seating closest to the field. The steel roof trusses support intermediate steel bar joists spaced at approximately 6'-0" on center. Bridging has been provided for the stability of the bar joists. The steel bar joists support metal roof deck. The roof framing appears to be in fair condition, some corrosion was noted.

Most of the finish grade in the area below the substructure is dirt and should be fenced off to prevent people from walking in areas where headroom height is limited. Sidewalks and concrete ramps have been provided for access to the grandstand.

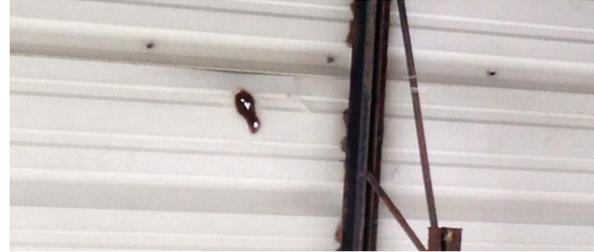
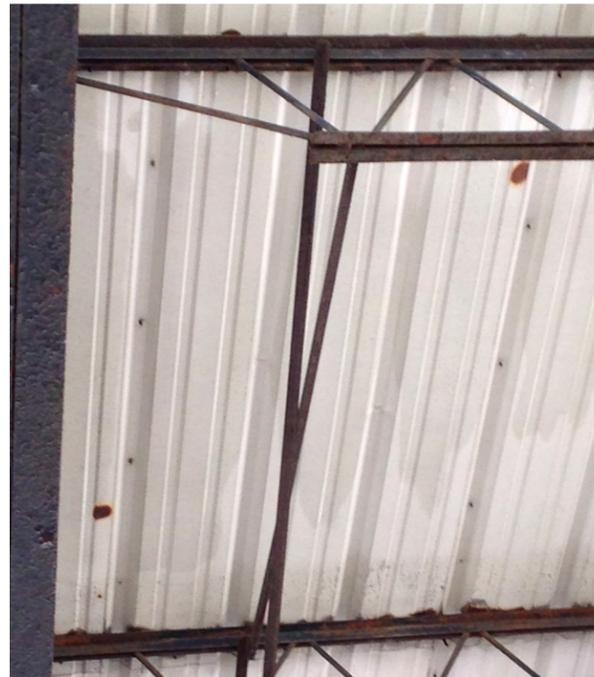
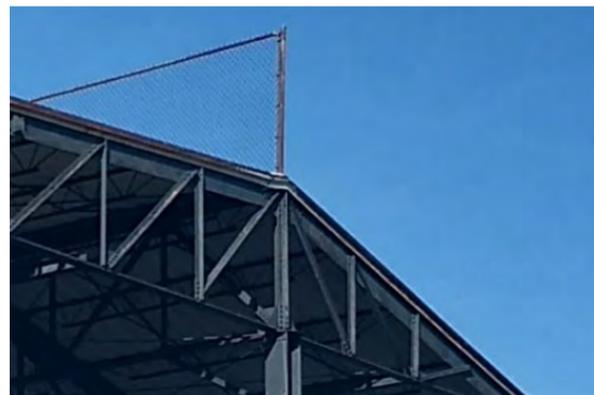
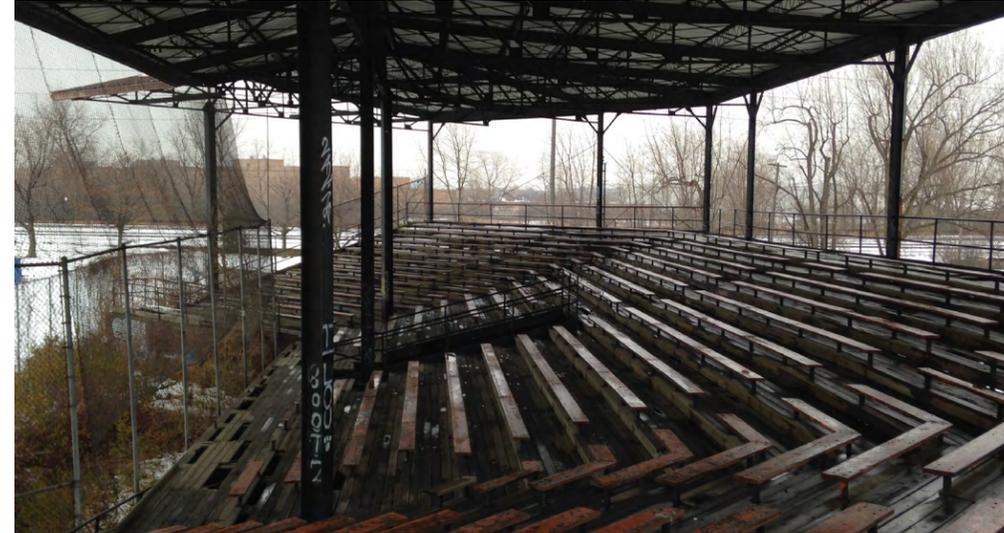
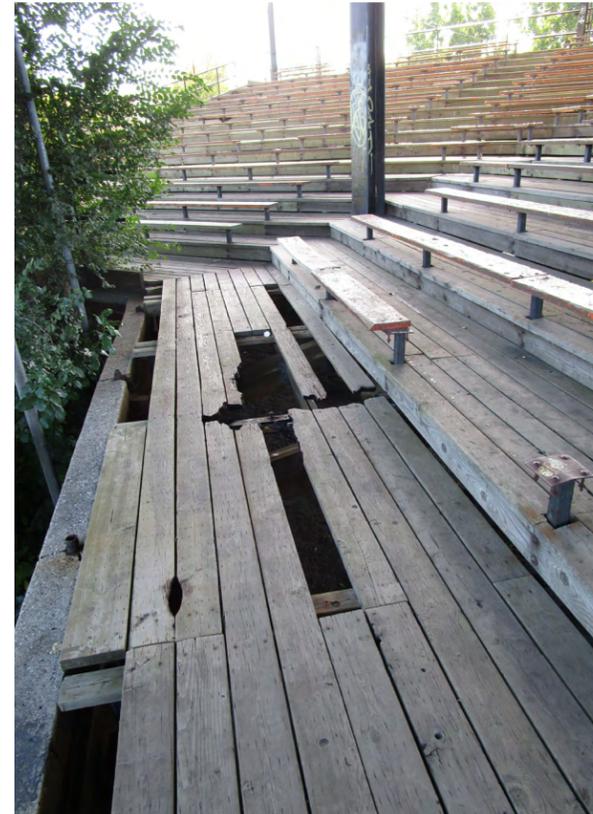
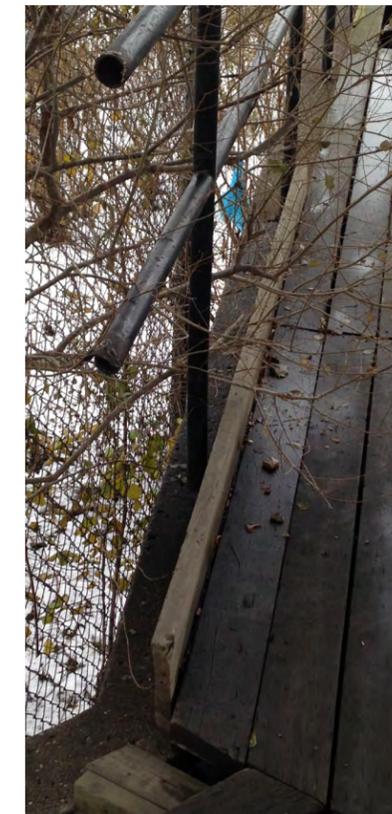
The existing grandstand accommodates 1,350 spectators on wood bleacher seats that are divided into six seating sections. Spectator capacity is calculated based on 18" seat widths. All the spectator bleachers consist of single 2x12 wood planks bolted to the top of a square steel plate welded to vertical metal stanchions. Similar to the grandstand decking, the wood bleacher seating planks have deteriorated, split or become dislodged due to long term exposure to the moisture and weather.

Figure 3.39
Rust damage to corrugated metal roof

Figure 3.41
Broken metal pipe railing

Figure 3.42
Deteriorating cross-aisle

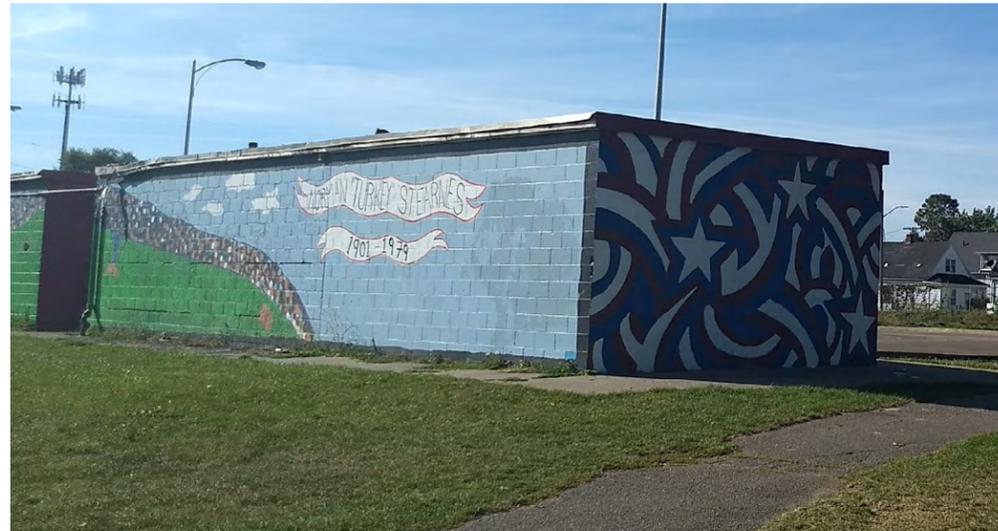
CLOCKWISE FROM TOP LEFT
Figure 3.101
Northeast exterior view of Building 5.

Figure 3.102
Utility sink in Building 5

Figure 3.104
Interior view of south wall in Building 5.

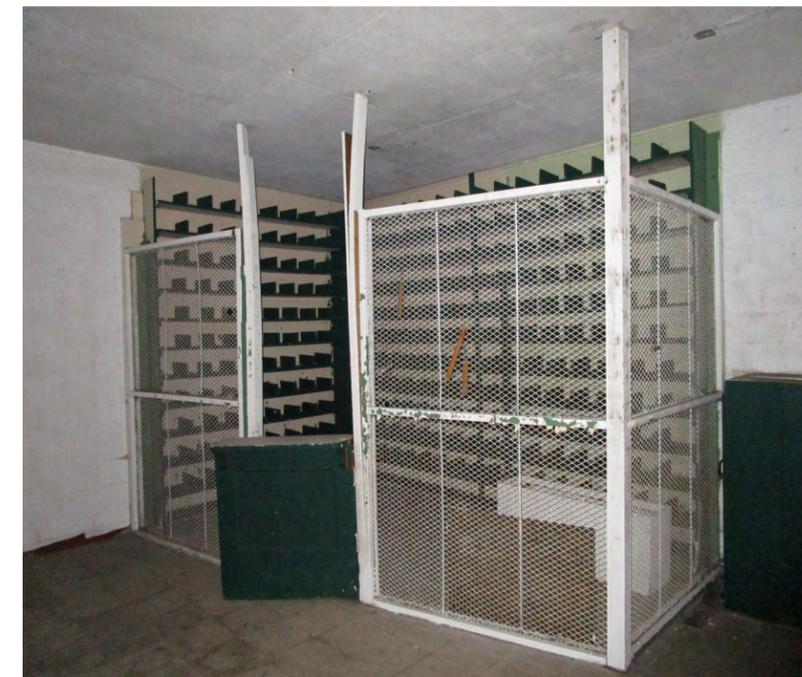
Figure 3.105
Interior view of southwest wall in Building 5. Note concrete masonry unit infill in window behind wood counter.
